Lessons Learned LL2022 – 5005

Fire on Poop Deck aft Mooring Station

Type of Incident: Fire

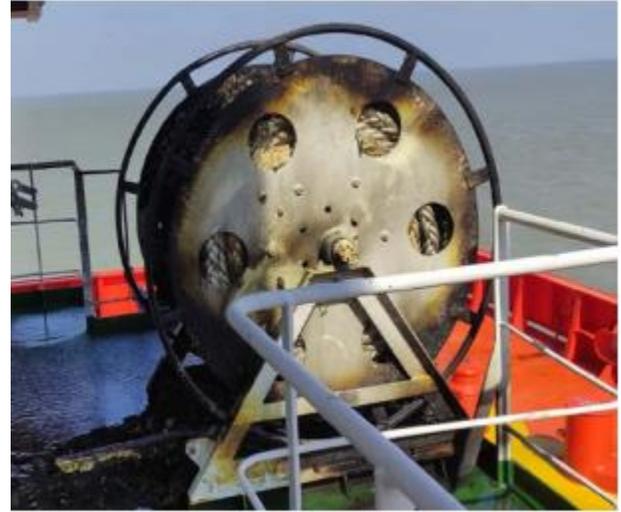
The Master sent the Bosun to check the location. The Bosun reported back that heavy smoke and a minor fire was observed on the poop deck from the mooring rope storage drum, at the starboard side rail where the rope was coiled/secured.

Deposits of carbon / soot from the main engine funnel.

Insufficient combustion due to fuel oil injection system causing excess accumulation of carbon in the exhaust boiler. Sudden increases of engine load may release accumulated carbon deposits.

- Fuel oil injection system to be maintained in good order and Nutshell cleaning of turbocharge for main engine to be completed according to makers instructions
- If canvas is used to protect the stored mooring ropes, fire prevention canvas **shall** be used
- Crew to be observant and keep an eye on carbon / soot dropping on the vessel
- Share this LL with the crew and discuss the event at next GSM.
