# Lessons Learned

## Large volume spill with high cleanup cost implications

**What:** 1,500 gallons spill of PDCB

**Where:** Houston Terminal, US

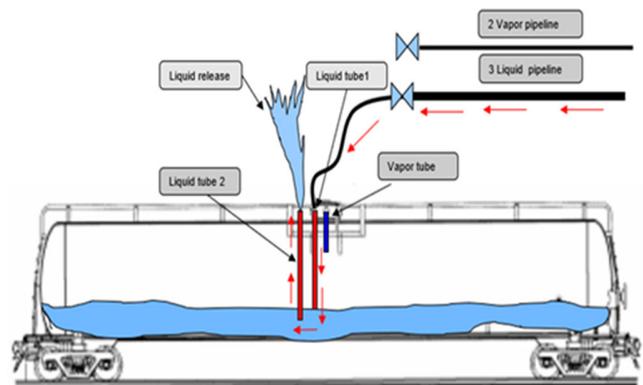
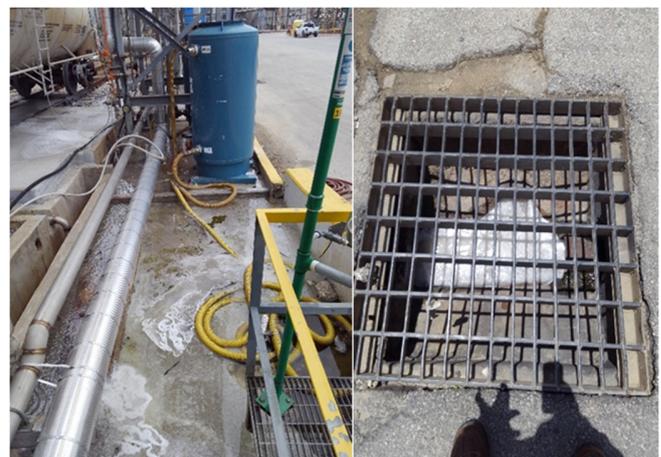
An operator failed to connect the vapor line hose on a railcar during a Paradichlorobenzene (PDCB) load and abandoned his post during the transfer spilling approximately 1,500 gallons around the railcar and into the storm water system.

On 22-June-2021, an experienced operator was loading a railcar with PDCB, and after completing 25% loading, the product started to come out from the 2" valve located on top of the railcar and into the nearby stormwater system. The operator was more than 300 feet away and was therefore not able to react quickly and stop the spill. As PDCB solidifies at atmospheric temperatures it plugged the stormwater pipe on contact.

The operator decided to release pressure through the secondary liquid line and failed to connect the vapor line as required by procedure. Because the line-up was incorrect, the railcar started to build pressure during the loading operation and this pressure was released through the 2<sup>nd</sup> liquid tube because the valve was open. The operator also abandoned his post and was approximately 300 feet away when the spill took place so was not able to close the valve and stop the transfer quickly.

- The operator failed to follow clear procedures which detail proper valve alignment and hose connections
- The operator failed to install the level probe indicator as a secondary barrier to prevent an overflow

- The operator failed to follow the DOT regulation, that requires attendance at all times during loading, as he was more than 300 feet away from the loading spot when the spill happened
- Because of the solidification of PDCB at atmospheric temperatures, the spill required extensive and costly cleaning work
- All operators were reminded to closely follow procedures and protocols at all time
