**Type of Incident: Loss of top joints of fingers**

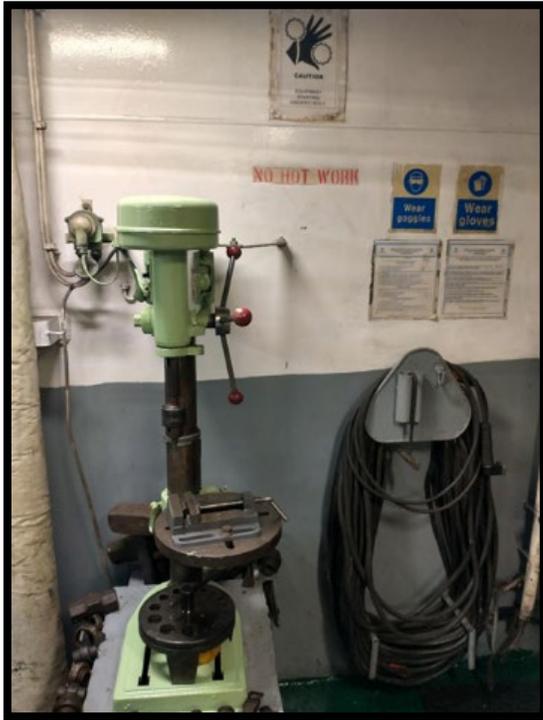
While tightening the chuck of the bench drill with a chuck key the drill rotated under power. A wire loop on the chuck key trapped the crewman's fingers, immediately severing the distal phalanx of the middle and ring fingers. The bench drill has a foot operated switch, the function of which breaks contact when a foot is placed on it and activates when released. The crewman had his foot on the foot switch while fitting the bit, and had removed his foot while still turning the chuck key.

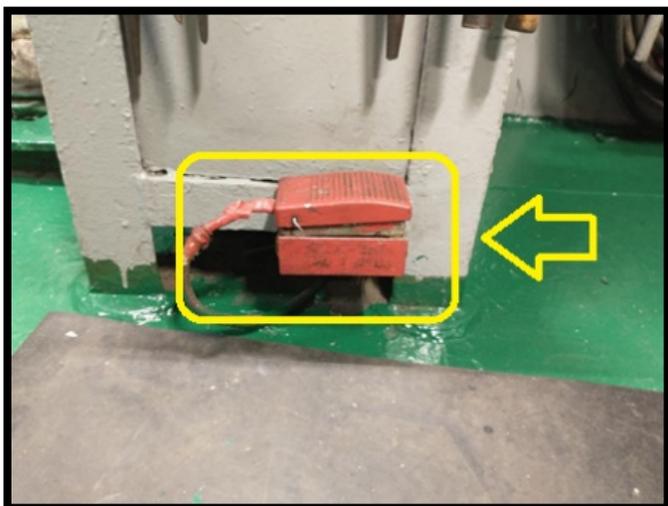
The phalanges of the fingers were severed by the wire tied to the chuck key which had wrapped around the drill bit when the drill rotated.

The power had not been disconnected from the unit.

Failure to maintain pressure on the foot switch. power not isolated

The foot switch was incorrectly wired, the situation had existed for some time and not been corrected although it had reportedly been recognized by the Engineers. The situation was manifestly unsafe, and yet no positive action had been taken to rectify it, it had simply become "normal".

- A fleetwide notification to be promulgated confirming the correct operation of foot switches and verification that independent emergency stops are in place
- Wire loops to be removed from chuck keys
- A note to be placed close to the drilling machine requiring power to be isolated before changing drill bits
