**Incident:**

**A trainee operator crushed part of his thumb between a railcar and locomotive. The thumb had to be partly amputated.**

**Where:** NNOAT, Antwerp, BELGIUM

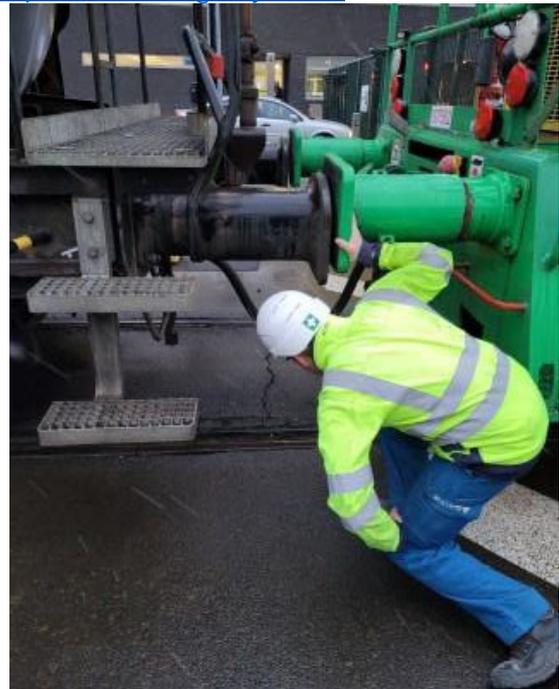
To access the coupler and disconnect it, the trainee put his hand on the side of one buffer and then bent under the buffer. By doing so, he left his thumb sticking out in the gap between both buffers.

As the filled railcars had been moving before stopping, due to the inertia of the liquid (phenomenon also called as the slushing effect), the product inside the railcar tank was still moving, and therefore caused the railcars to move, and hit the locomotive. Consequently, the locomotive buffers and the railcar buffer hit each other, causing the sticking thumb to be crushed in between.

- The Task Risk Assessment and Work Instructions for coupling and decoupling of railcars will be updated to mention the risk related to the slushing effect and to avoid putting a body part in the "line of fire"
- Training program will be changed to:
  - ensure sufficient time to be provided to perform training
  - limit the number of trainees when training is received "on the job"
- Incident to be shared and discussed amongst the shift teams and to be included in the last-minute risk assessment
