Incident:

What: Nitric acid leak in a tank pit

When: 15-Jun-22

Where: NNOAT, Antwerp, BELGIUM

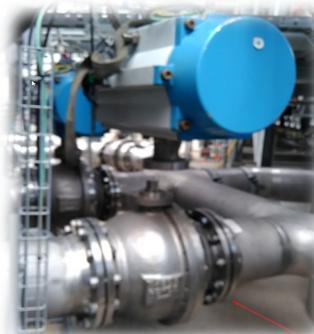
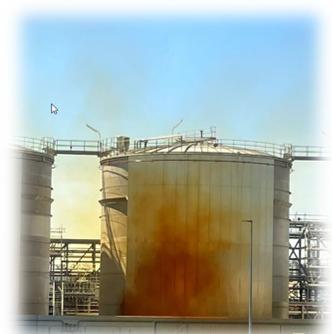
During the initial commissioning of a new tank, a spill of 600 liters of nitric acid occurred. The spill came from a leaking gasket on a valve flange. The isolation valve actuator did not close the valve completely resulting in a continuous small product flow. Manual intervention was required to tighten the bolts of the leaking flange connection and stop the leak after 25 minutes. Due to the reaction with the oxygen in the air, yellowish and brownish vapors were formed.

During the commissioning, when opening the high suction valve, a leak immediately appeared on its flange, at the bottom position. The operator and contractor present at that time evacuated everyone from the premises and alerted the control room operator who attempted to close the high suction valve and stop the leak, but the valve automation did not close the valve completely. The nitric acid vapors caused colored fumes to quickly appear, and firewater was rapidly used to neutralize them, successfully.

The intervention team with adequate protection removed the nitrogen from the valve actuator to get the valve in the fail-safe close position which must happen in case of nitrogen pressure loss but this did not work, and the team had to stop the leak by tightening the bolts. The actuator was then disassembled, and the valve was closed manually without a problem.

After the spill clean-up, it appeared that joints in the tank pit and the collecting gutter were affected as they were not resistant to Nitric acid.

- For similar valves located in the same tank pit, the tightening of the flanges was verified and corrected where needed
- is required to perform blinding or line breaking
- Requirements concerning line supporting and pressure test were included in the maintenance procedures
- Signage was installed where the use of supporting hoist
- Local practice will be reviewed to avoid commissioning of tank in product for harmful products
- The project specification procedure is to be updated to include requirements for
 - Valve throttling position to be specified and checked against a certificate from the supplier
 - Resistance joint compatibility need to be specified
