Incident:

What: 900 hp boiler tubing leaks

When: September 21, 2021

Where: Houston Terminal, US

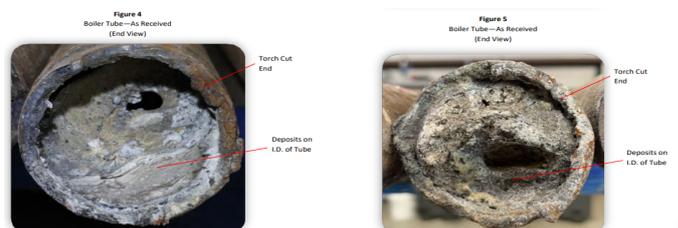
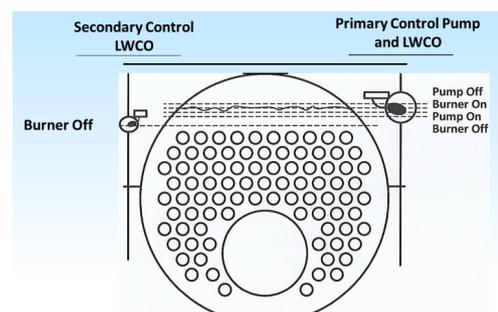
Multiple boiler tube leaks developed in the interior chamber of the 900hp boiler resulted in an unplanned maintenance downtime.

The water level inside the boiler chamber is controlled by instrument relays. There were intermittent issues with the low-level water cutoff instrument causing an inefficient water level that was used to protect the tubes while the boiler is operating creating steam. As a result of the low water, boiler tubes that were not immersed in the boiler water, the excessive heat expanded the tubes creating the tube leak inside the boiler. Additionally, a severe scaling buildup had occurred on the lower portion of the lower tubes because of a less than adequate daily blowdown process resulting in corrosive pitting, further compromising the integrity of the tubes.

- Perform GAP analysis on preventive maintenance program and develop Maintenance Plan (for equipment & instrumentation) including monthly/quarterly/annual inspections on the boiler by issuing a contract to the selected vendor **(Q4 2022)**

- Review and re-train all utility operators on updated boiler start-up/shut-down and layup procedures **(completed)**
- Re-train utility operators on the blow-down process by verifying conductivity analyzer is 100% operational **(completed)**

- Complete monthly analyses on incoming water to the DA (Deaerator) Tank. Record and compare samples were taken at different locations such as upstream/downstream of water softener, feedwater, and boiler and evaluate results implementing improvements **(completed)**

- Ensure the system runs in AUTO (instead of MANUAL) from all aspects to ensure proper functionality of the system and determine best method **(completed)**

- 2022 capital expenditure project will provide visibility of the boiler's functional state in the control room and the maintenance shop **(Q4 2022)**
- New coiler will be installed and commissioned by end of 2022 and will be utilized as the primary with the existing 900hp boiler used as a backup **(Q4 2022)**
